NBS TECHNICAL NOTE 807

Building Performance in the 1972 Managua Earthquake

Following the Managua, Nicaragua, earthquake of December 23, 1972, a team of engineers representing the U.S. Department of Commerce's National Bureau of Standards (NBS) and the National Academy of Engineering (NAE) performed field investigations in Managua, Nicaragua, from December 26, 1972, to January 4, 1973. The objectives were to assist the Nicaraguan government in surveying major buildings to determine whether each was suitable for emergency use, repairable, or appropriate for clearance. The team also viewed the patterns of successful performance and damage to identify needs for improvements in building practices for mitigation of earthquake hazards and opportunities for more detailed investigations which could provide information for future improvements in practices.

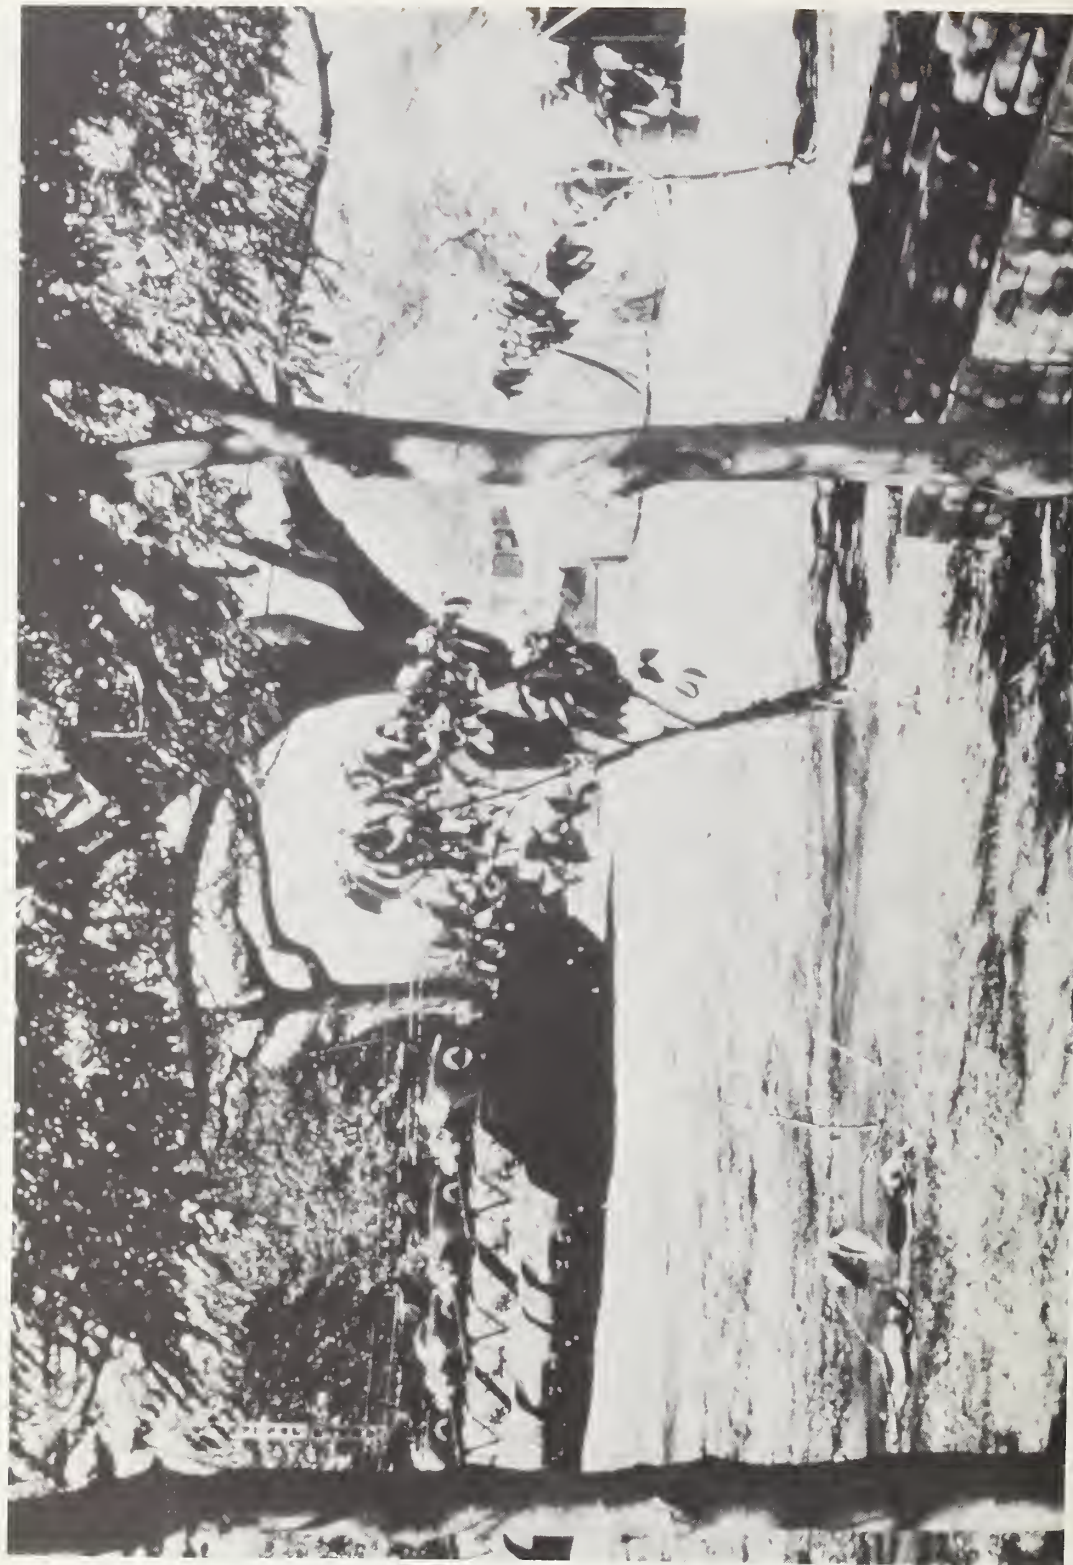
Figure 12 View of the Camp at El Retiro.

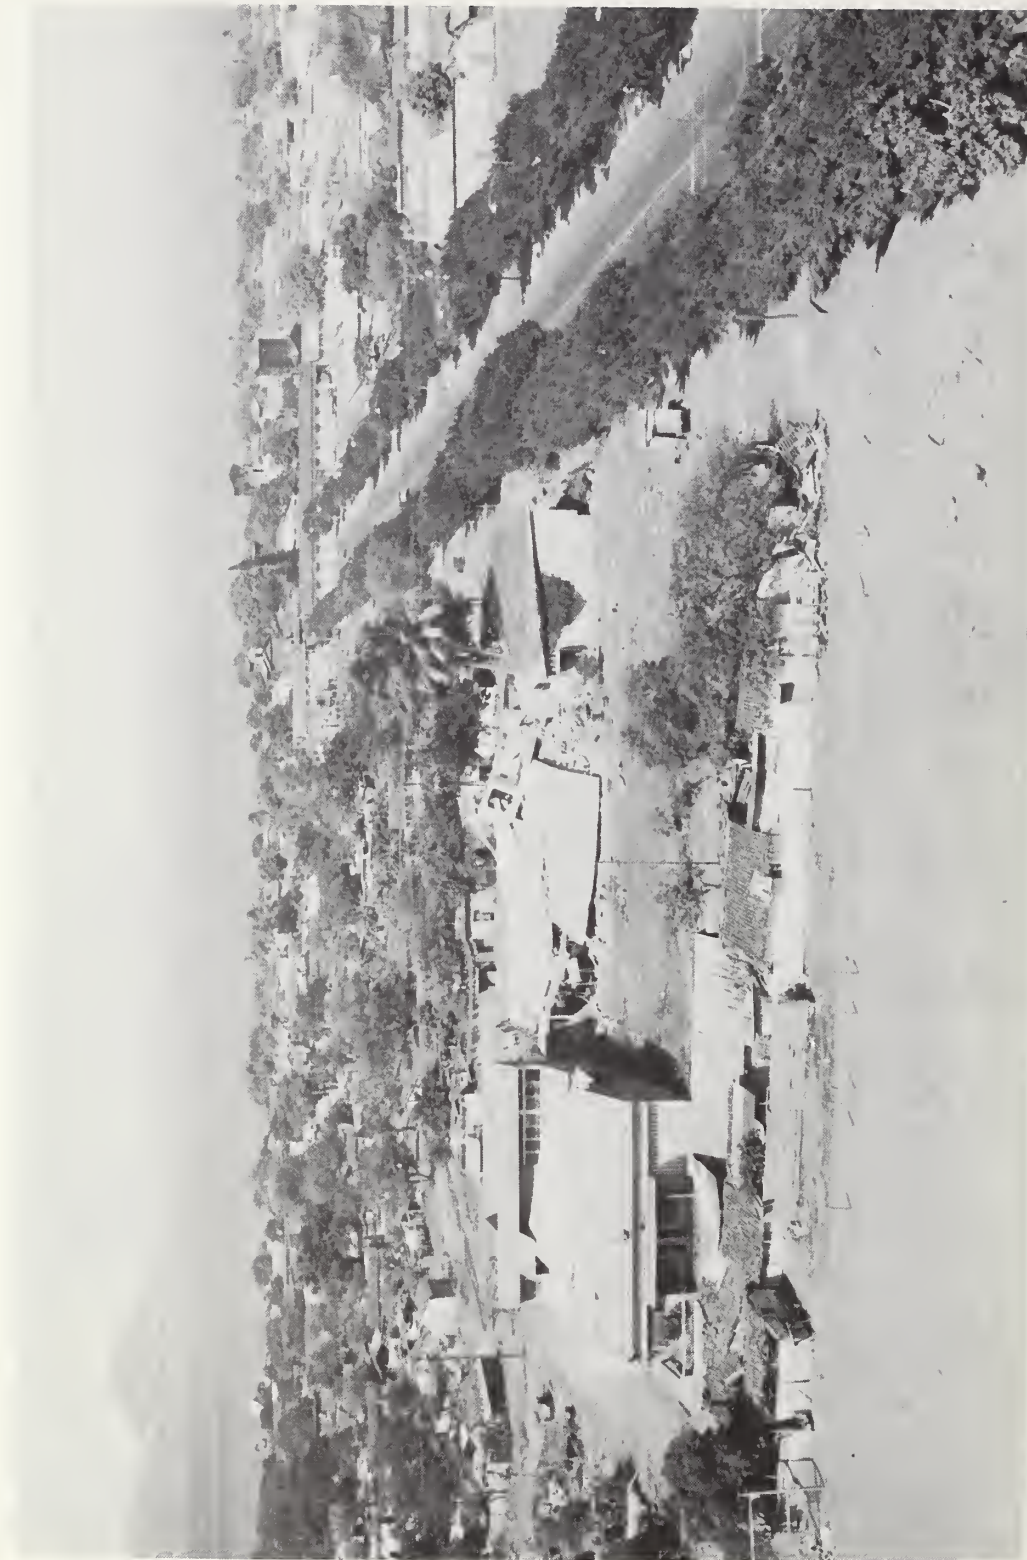
Figure 18 Red Cross building collapsed on ambulances and emergency supplies.

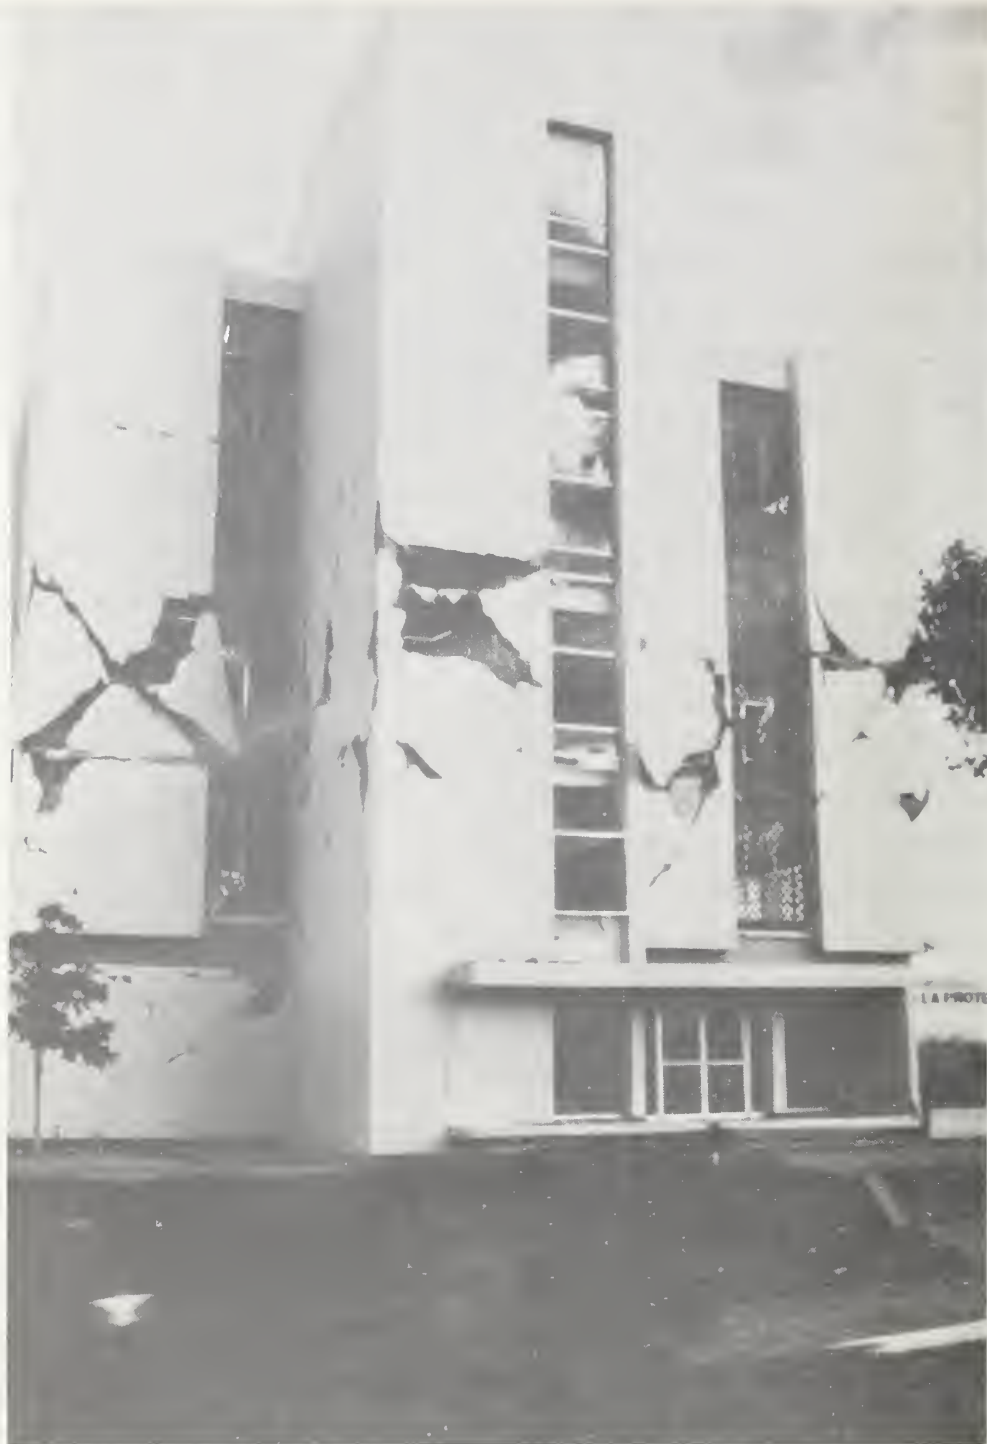
Figure 19 Severe exterior nonstructural damage in unbraced frame building, Seguros La Protectora.

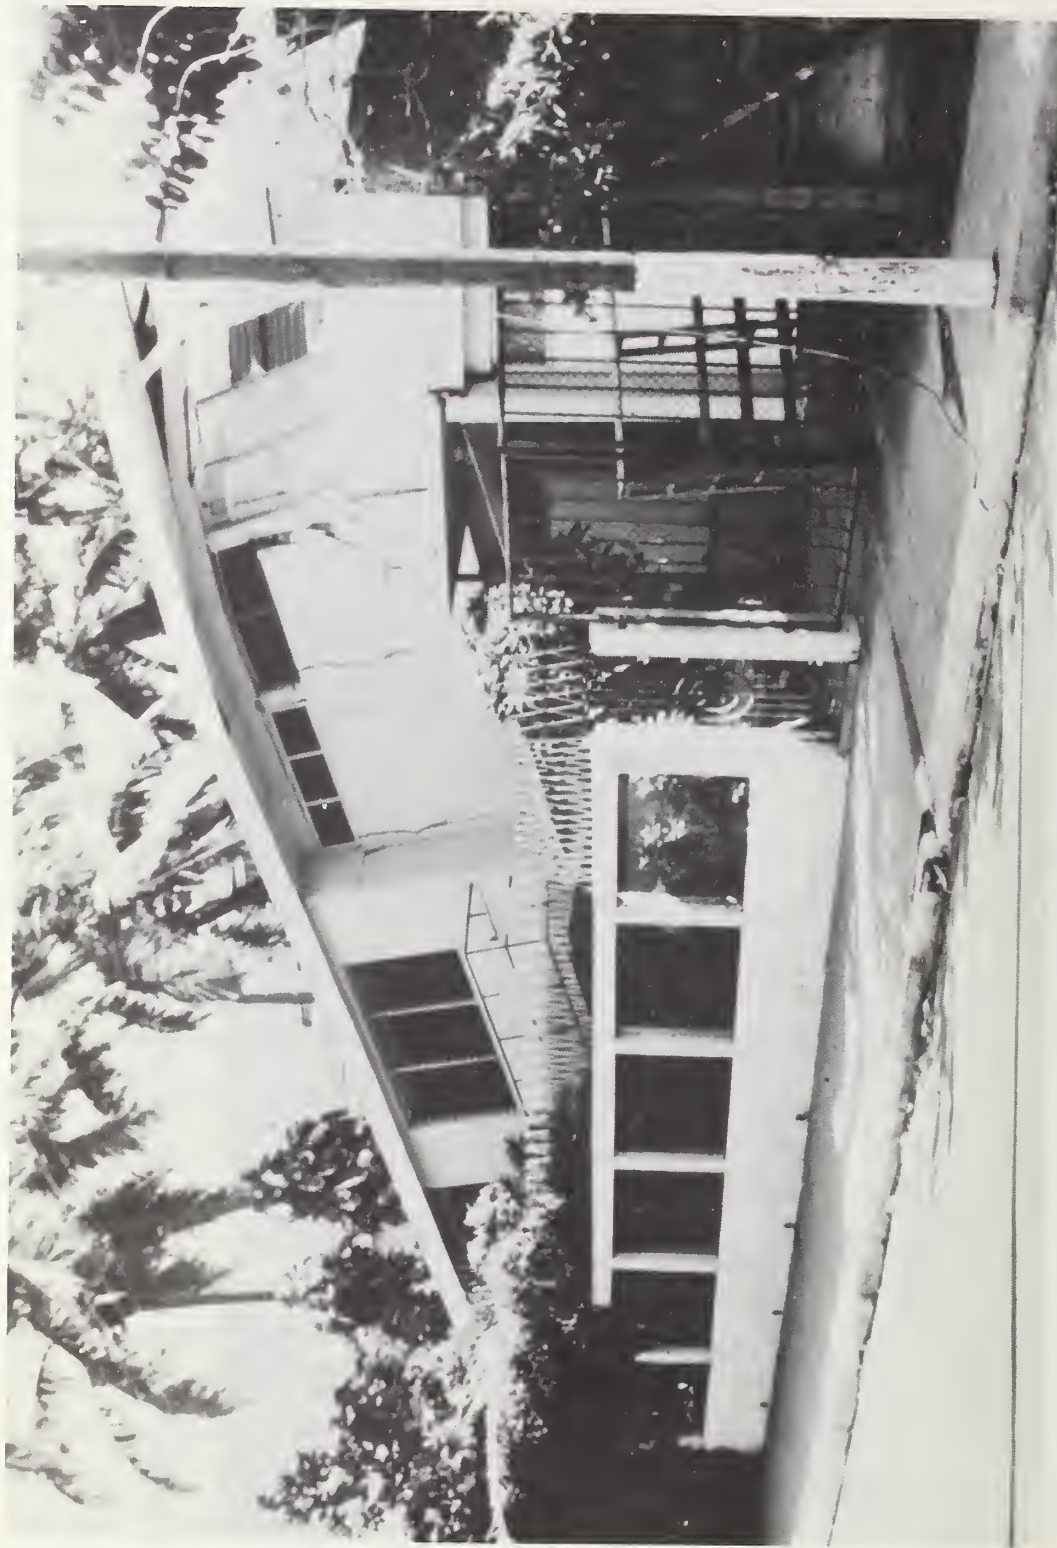
Figure 22 Collapse of modern house of "good quality."

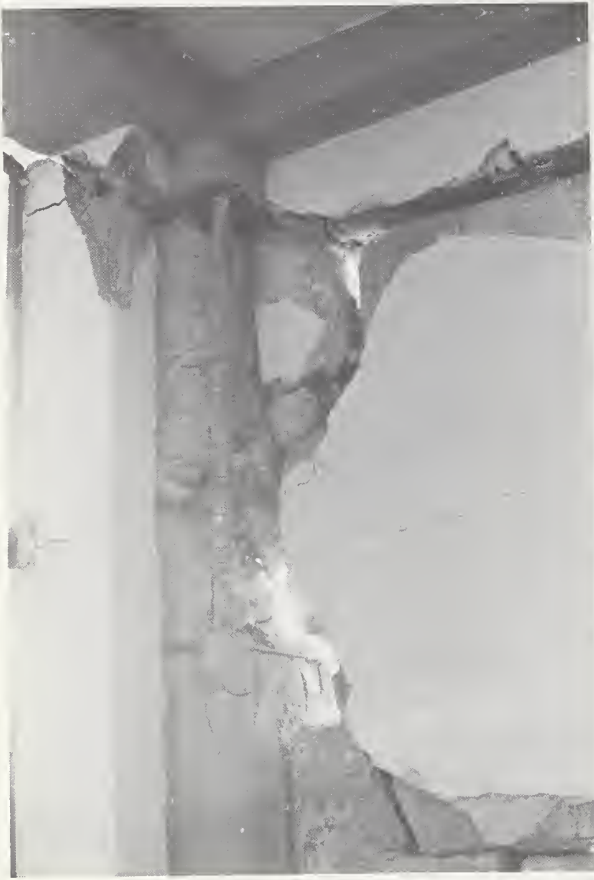
Figure 4-1 Column failure at construction join in nursery building, Mercado Periferico Oriental.

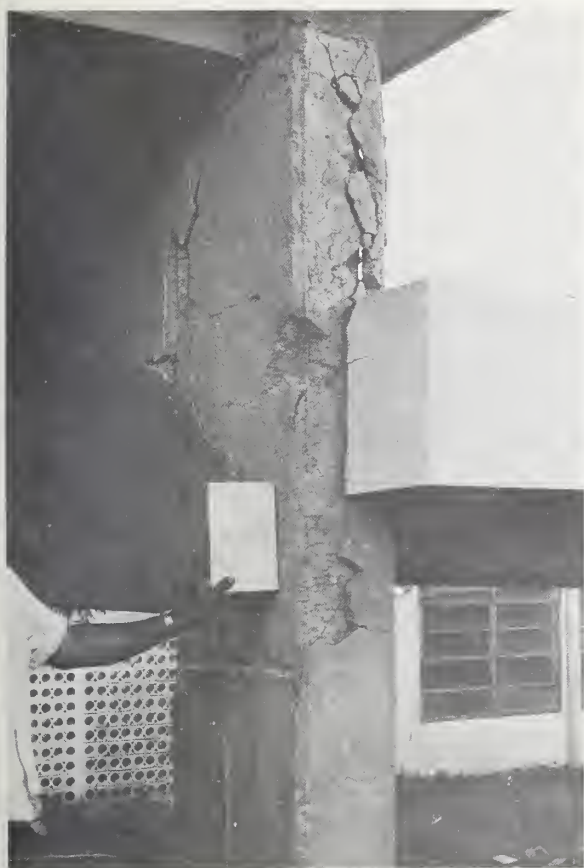
Figure 4-3 Damaged canopy columns at change of canopy elevation, Mercado Periferico Oriental.

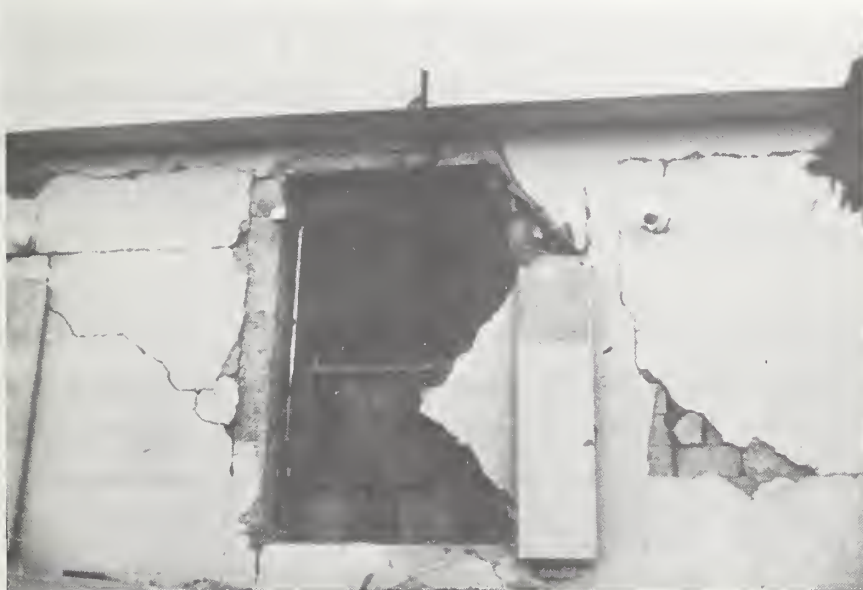
Figure 4-4 Wall and column damage in market building, Mercado Periferico Oriental.

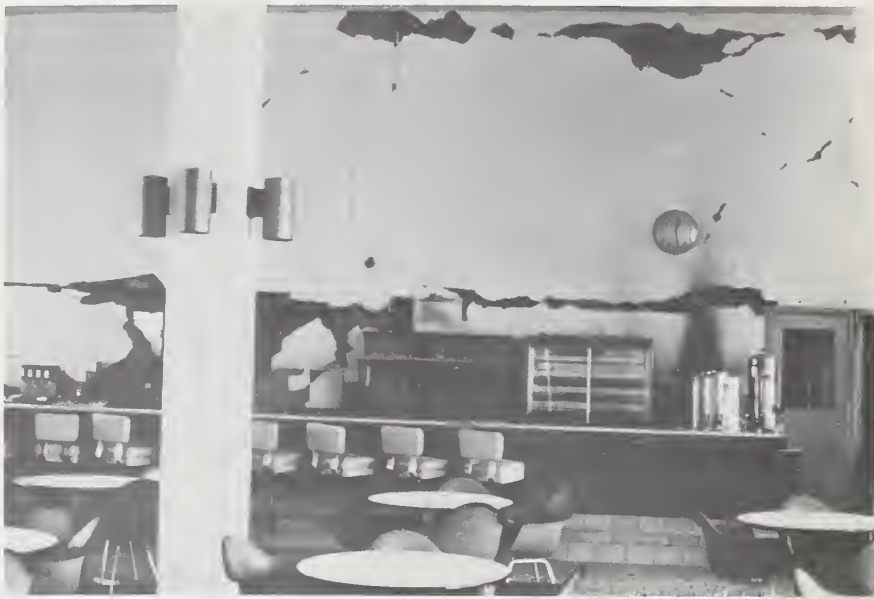
The visible damages are essentially nonstructural. There are strong cracks in the curtain wall to the east of the lobby which is built-in between the beams and columns and attempted to perform as a shear wall, figure 13-2. Cracks to the western curtain wall are less severe because this one overlays the beams and columns; there are deformations of anchors of this wall to the supporting elements and some crushing of the concrete around the anchors, figure 13-3. There is some cracking and displacement of finishing materials. The principal structural elements appeared to be in good condition. Some nonstructural elements of the building require repairs for proper function and security of the building occupants. The building may be cleaned up and returned to service promptly.

Figure 13-2 Cracked infill wall east of lobby, Aeropuerto Internacional.

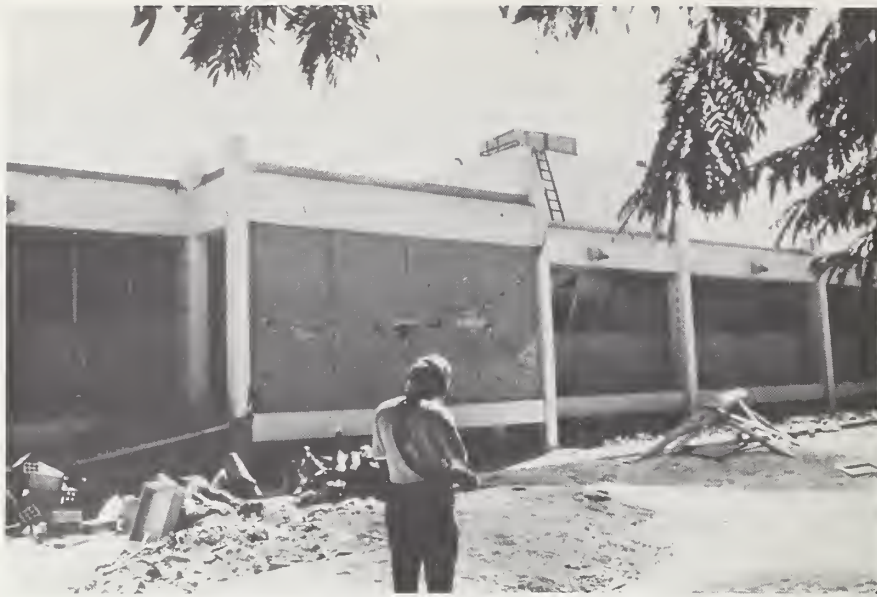
Figure 16-1 Severely damaged modern reinforced concrete frame building, INCEI administration building.

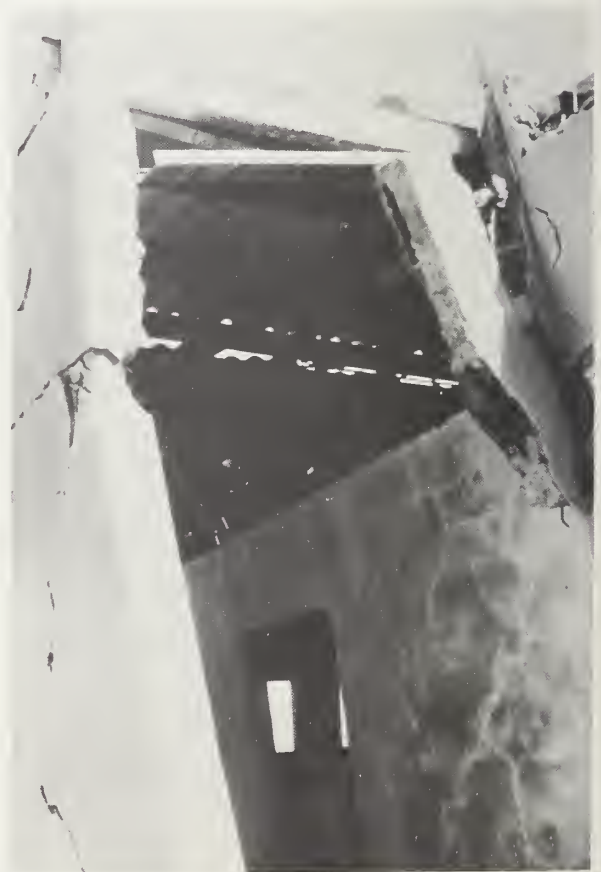
Figure 16-2 Damage from movement of inadequately braced roof, INCEI laboratory.

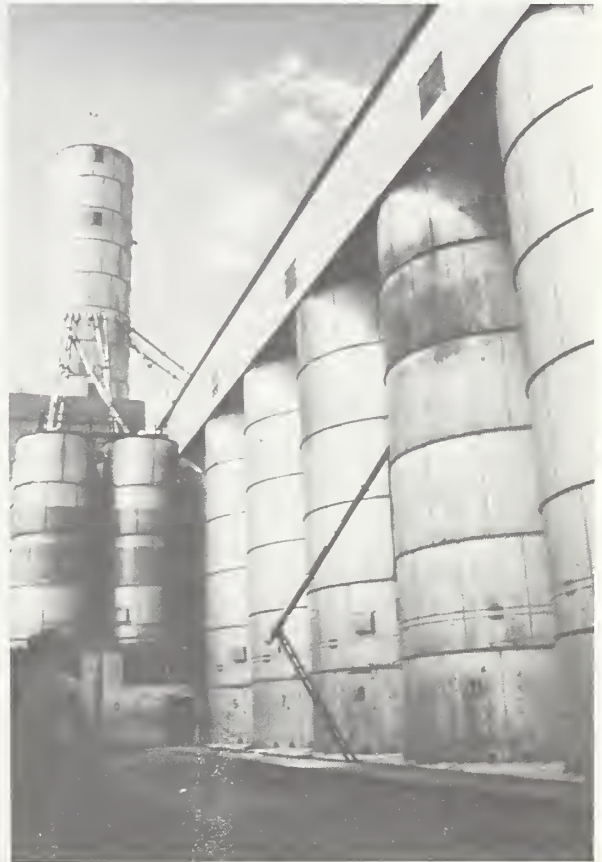
Equipment which should be functional following an earthquake must be adequately designed and anchored for earthquake forces. The power generation facilities for Managua were put out of service by small movements of the generators, inadequate anchorage of the boiler columns, figure 22-2, fractures of condenser castings, and sliding of unanchored transformers. The grain storage tanks of the INCEI, figure 16-4, showed uplifting of their anchor bolts to the south, figure 16-5, and local buckling of the tanks to the north, figure 16-6, as well as near the top, figure 16-4.

Figure 16-4 Shear buckling is visible at tops of INCEI elevators.

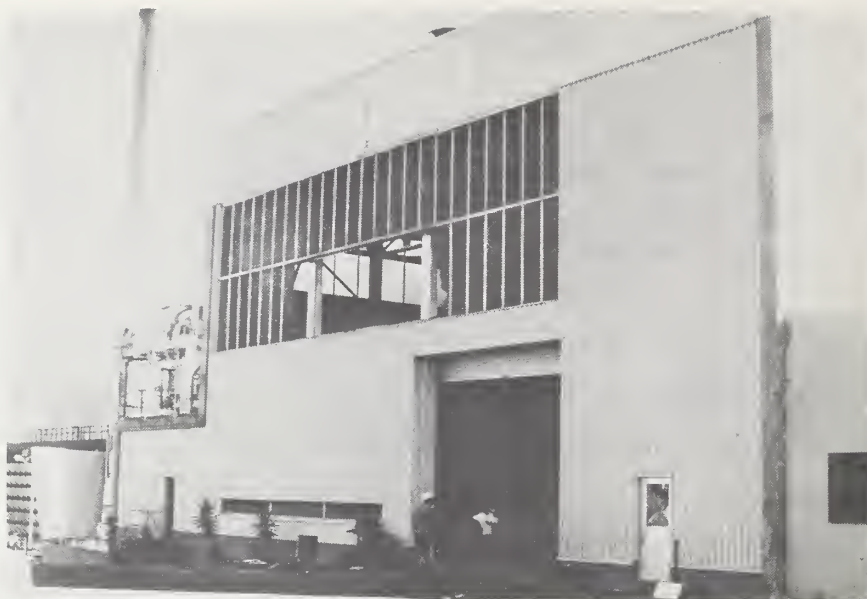
Figure 22-1 Only window damage notable in the main turbine building, Planta Eléctrica ENALUF

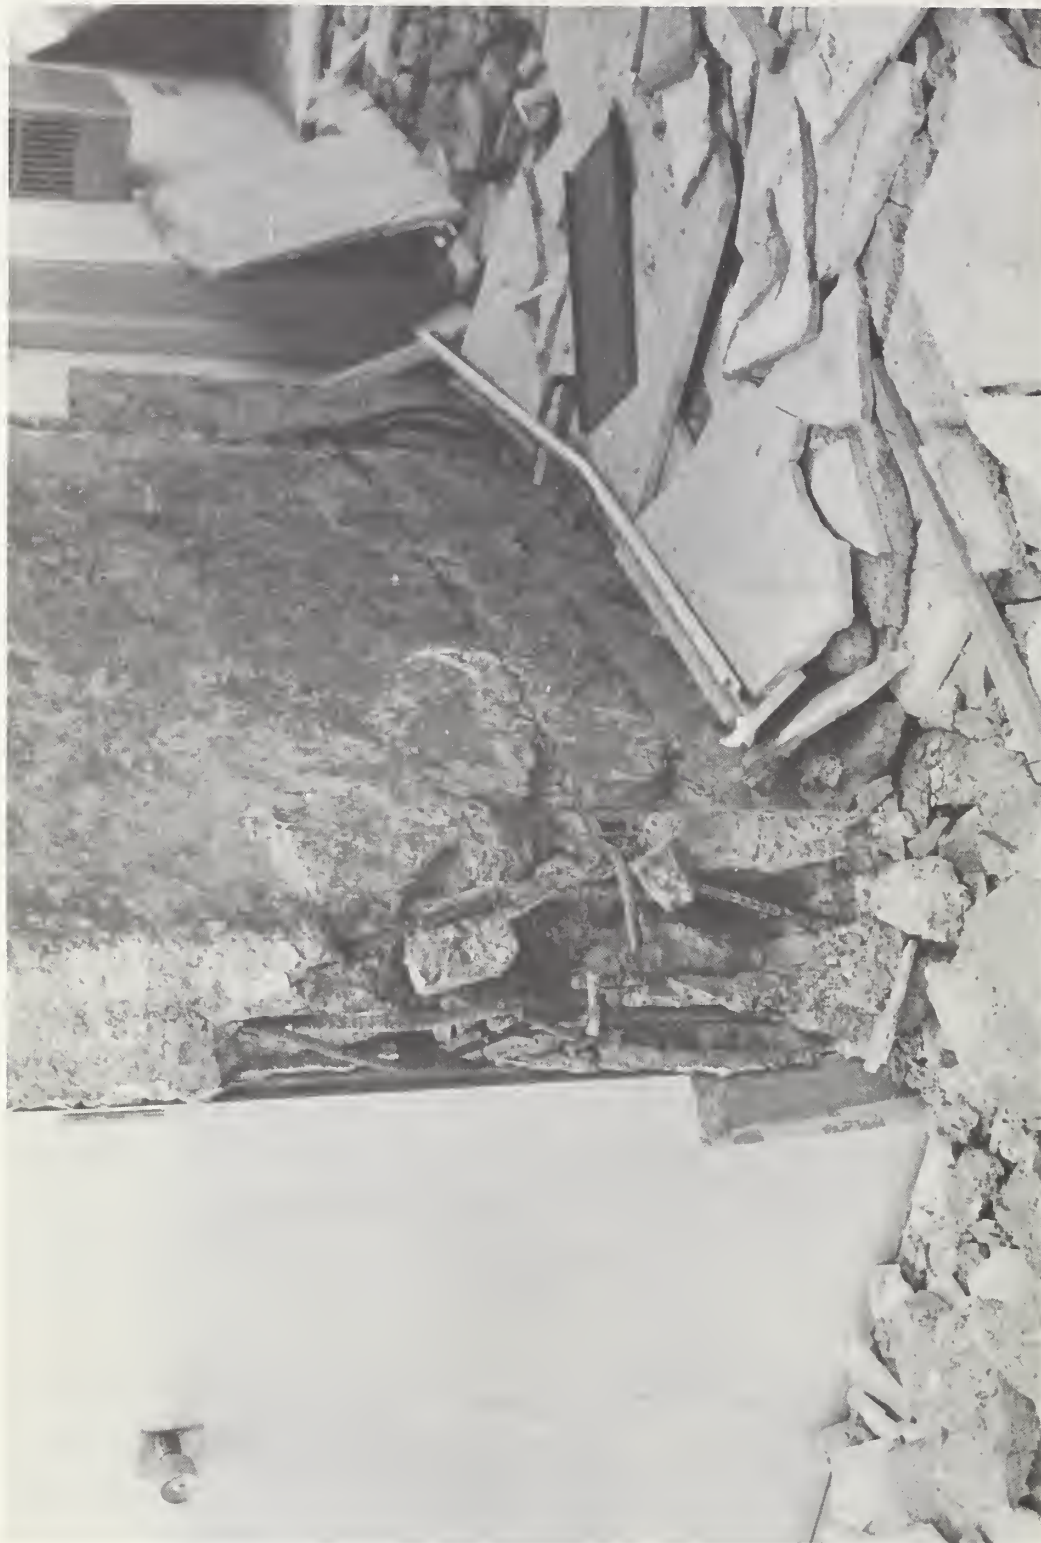
figure 23-4, and for a telephone chase, figure 23-3. On the upper floors there were many diagonal cracks in the shear wall, figure 23-5. The 17 story Banco de American Building also looked quite sound from the outside and showed little nonstructural damage on the inside, figure 54-2. However, many tie beams connecting the four shear wall towers at the corners of the core broke in shear at their mid-span where they were penetrated for ducts, figure 54-1.

Figure 23-3 Shear wall crushing at first floor
where weakened by telephone chase,
Edificio Administrativo ENALUF.

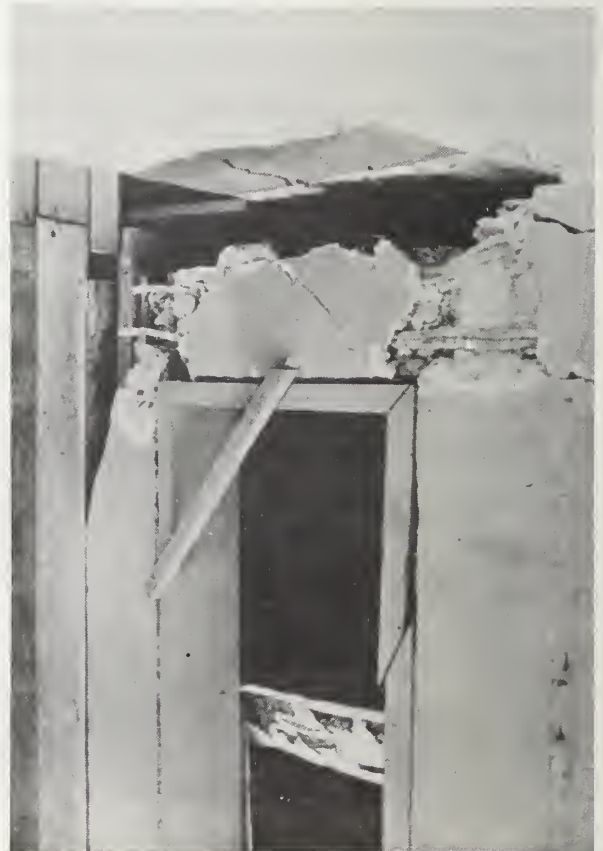
Figure 25-2 Failure of bond beam and column near aperture, note inadequacy of anchorage of reinforcement at corner.

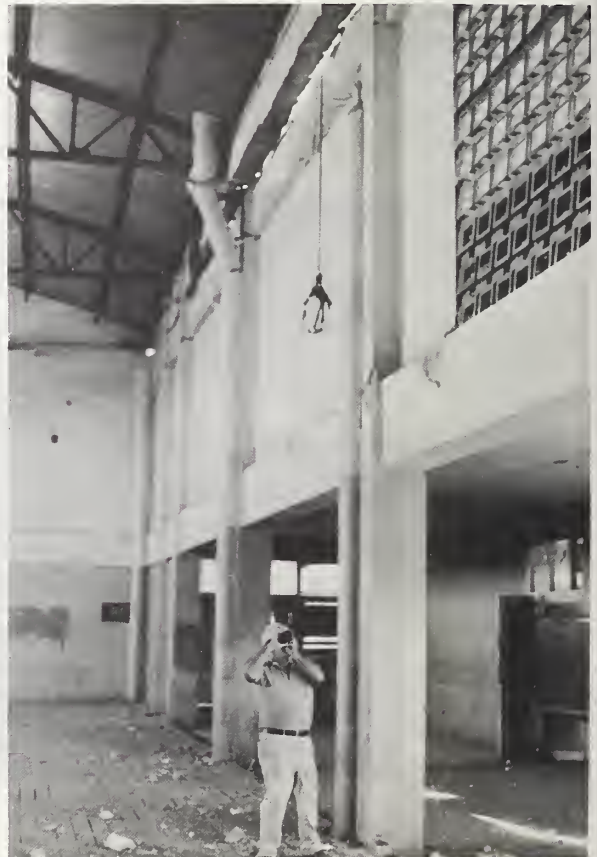
The need for proper horizontal distribution of the lateral forces induced by the earthquake also was evident in many situations. Trussed roof systems without lower chord bracing did not provide adequate horizontal diaphragm action. In a laboratory addition to the INCEI administration building, figure 16-2, the roof trusses severely displaced the end walls of the building. A similar failure occurred for the same reasons in the gymnasium of the Ramirez Goyena School, figure 38-4.

Figure 38-4 Broken wall on south side of gymnasium where school wing connects, Instituto Nacional Ramirez Goyena.

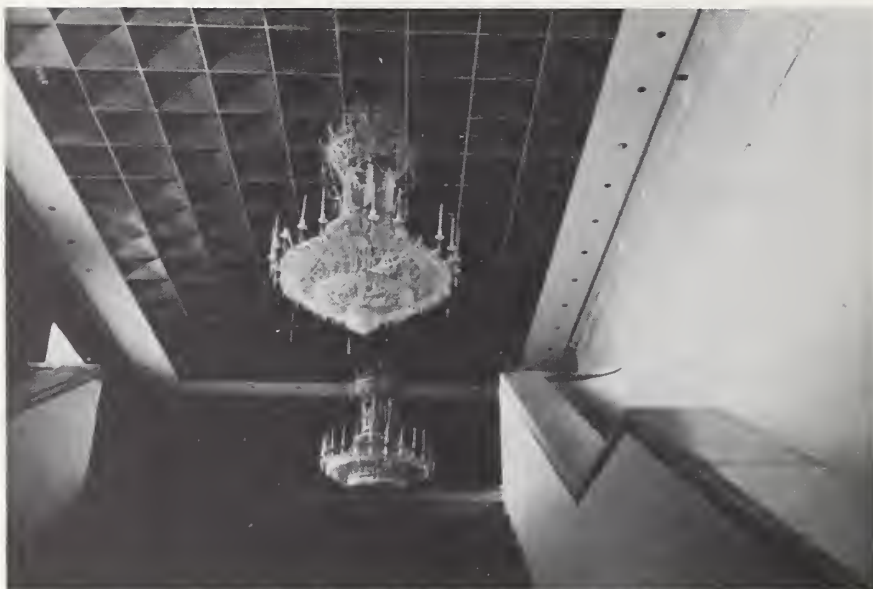
Figure 41-3 Minor finish damage amounted to fallen ceiling panels and some chips from the chandeliers, Teatro Ruben Dario.

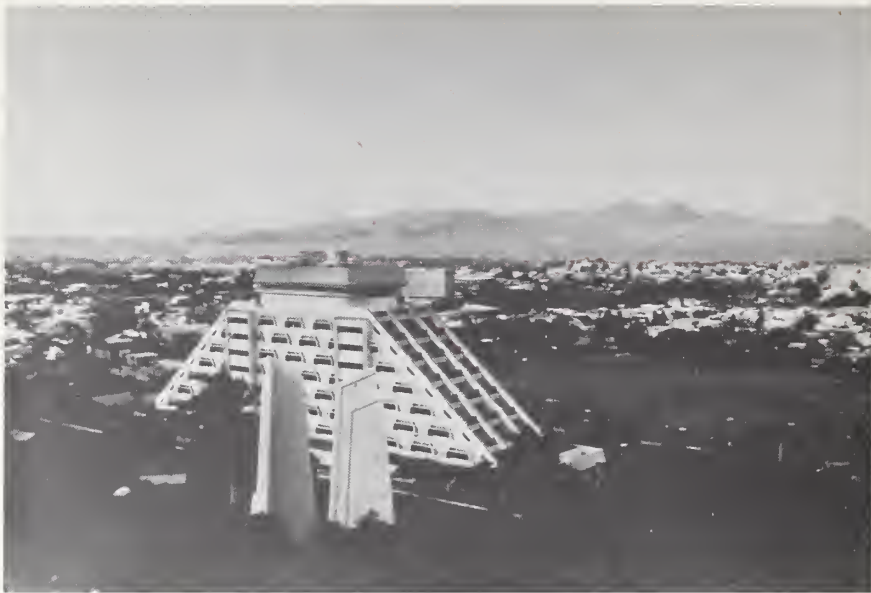
Figure 42-1 General view of Hotel Intercontinental.

- A. All beam-column connections (currently covered by architectural details) be inspected.
- B. The building reanalyzed before repairs for ground motion 1.5 times that measured at the Esso refinery or for ground motion resulting from a site study.

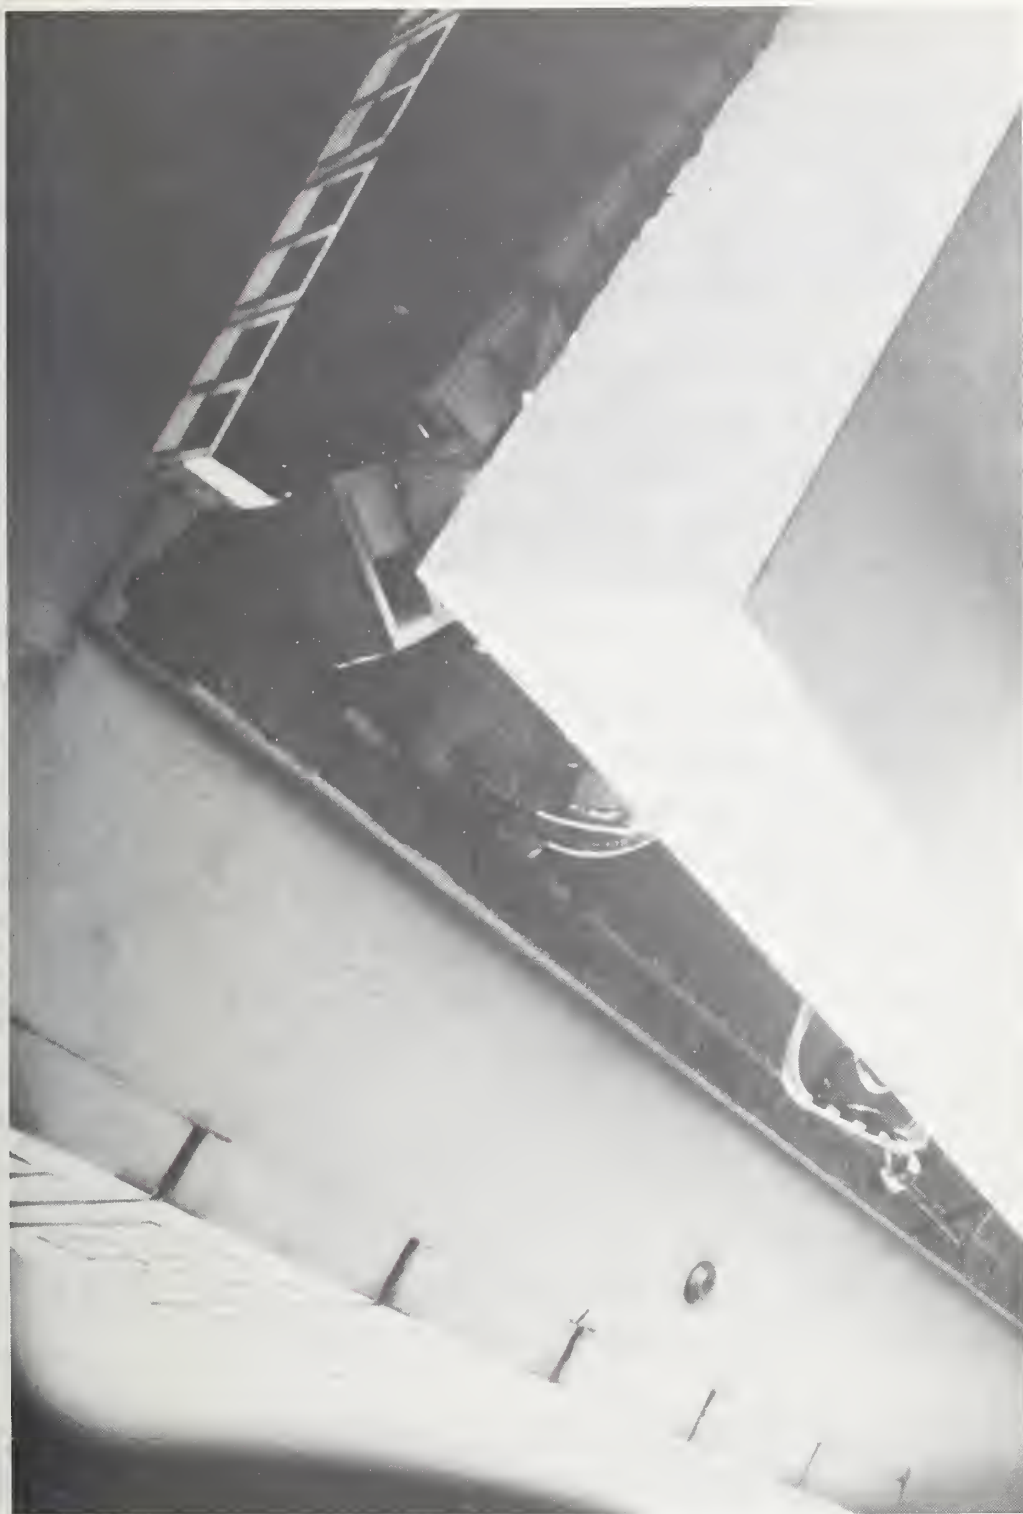
Figure 42-3 Failures of columns supporting mechanical penthouse, Hotel Intercontinental.

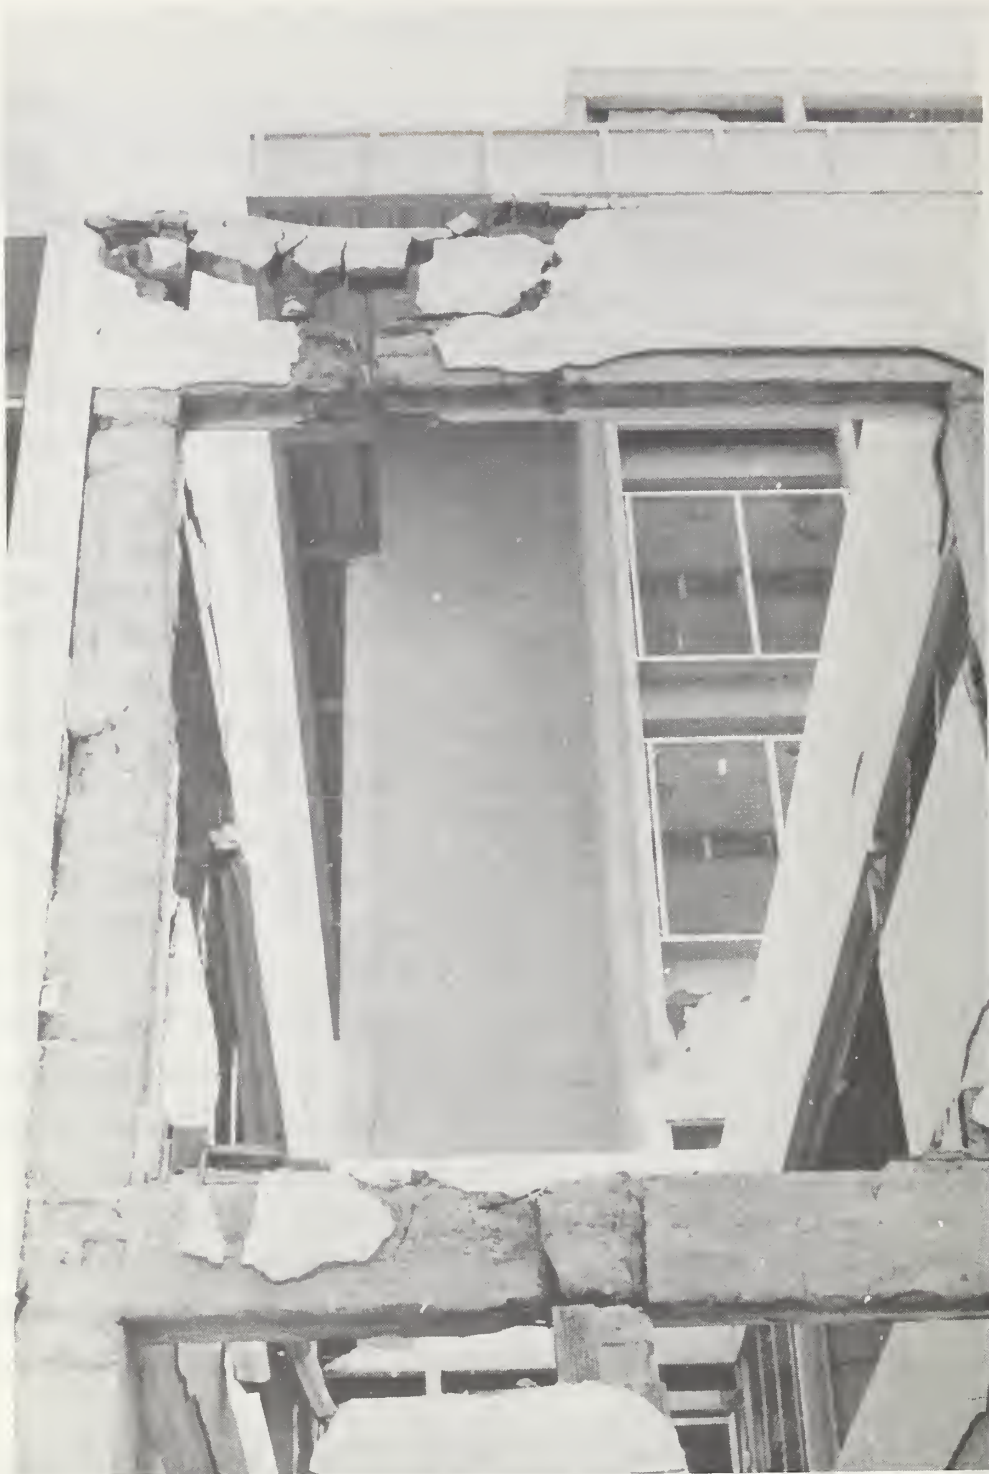
Figure 43-1 Ruptured beams connecting building elements across a courtyard, Corte Suprema de Justicia.

In general, it appears that these buildings can be returned to service following appropriate repairs which will include moderate repairs of damaged structural elements and major repairs of the non-structural elements of the buildings.

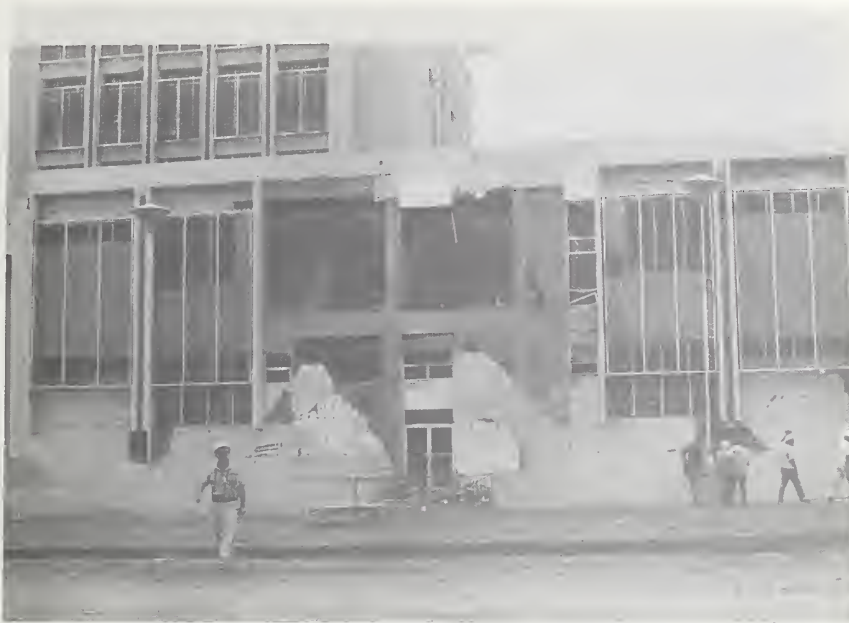
Figure 43-2 Extensive nonstructural damage in two story wing, Corte Suprema de Justicia.

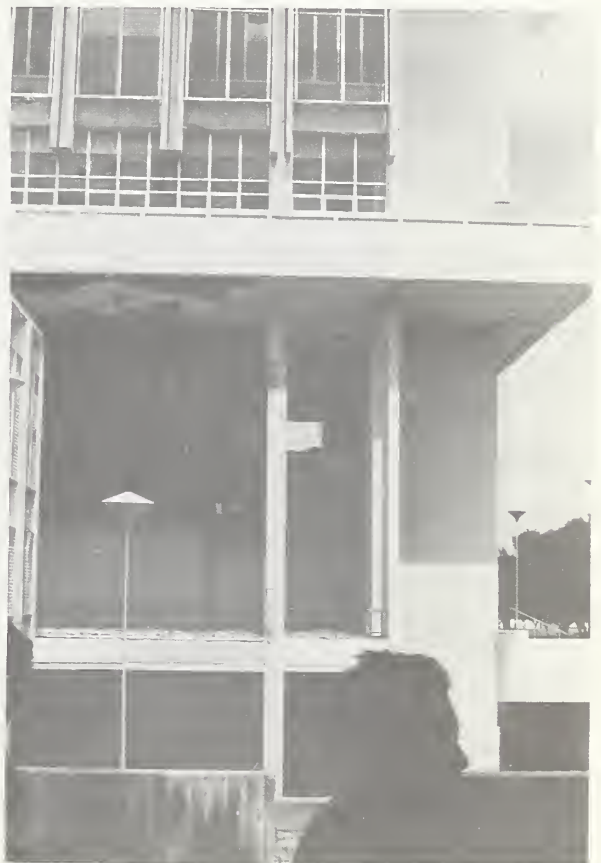
Figure 43-3 Nonstructural damage on 6 story wing, Corte Suprema de Justicia.

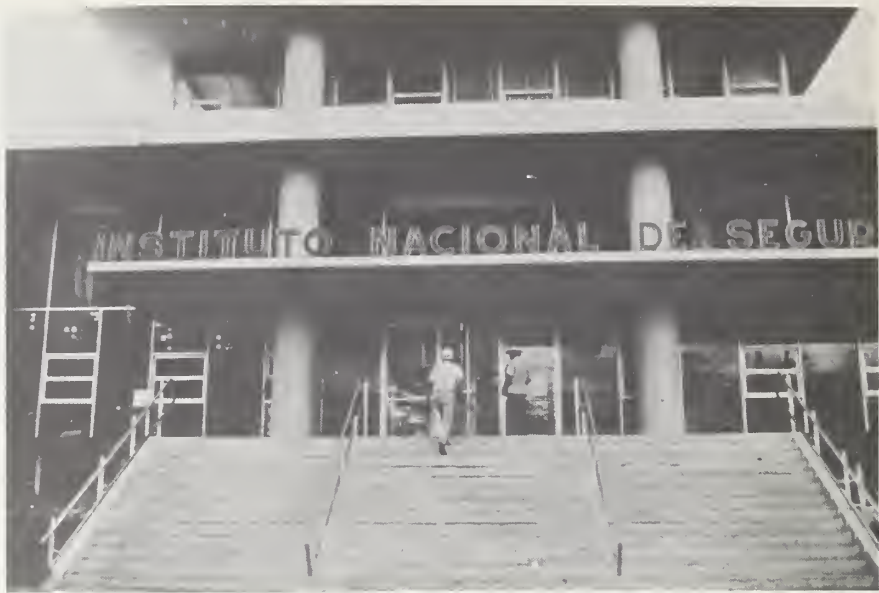
Figure 44-1 Main entrance to nine story frame showing absence of structural damage, Edificio Administrativo INSS.

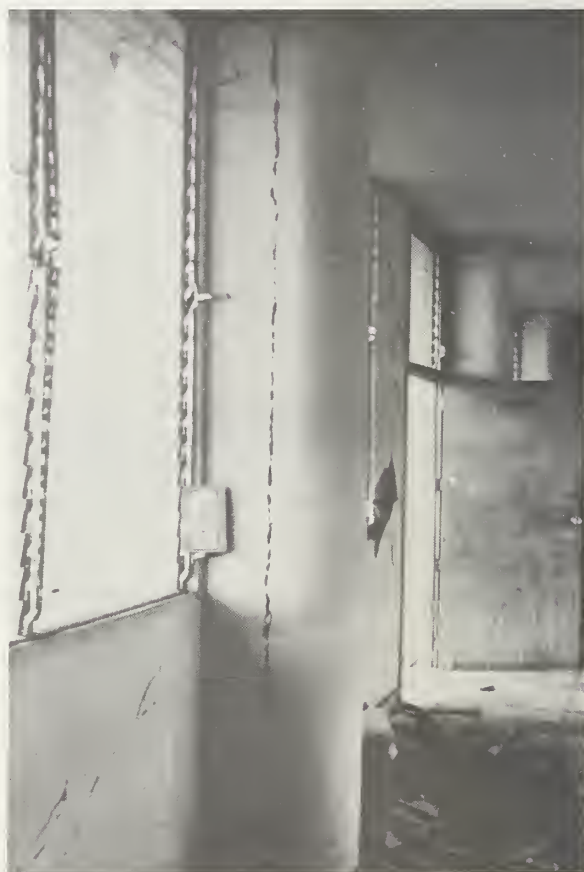
Figure 46-4 Cracking of columns,
Instituto Pedagogico.

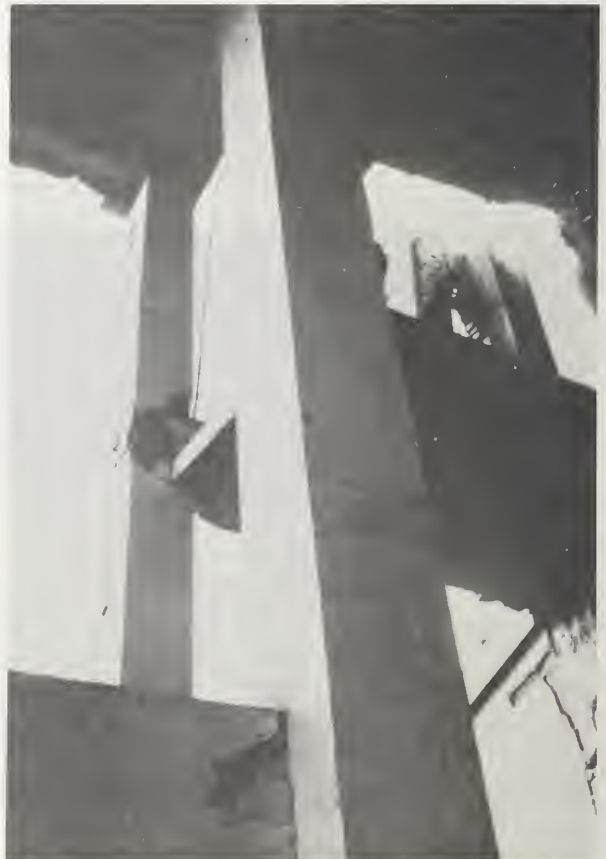
Figure 53-2 Damaged framing of gymnasium, Seminario Catolico.

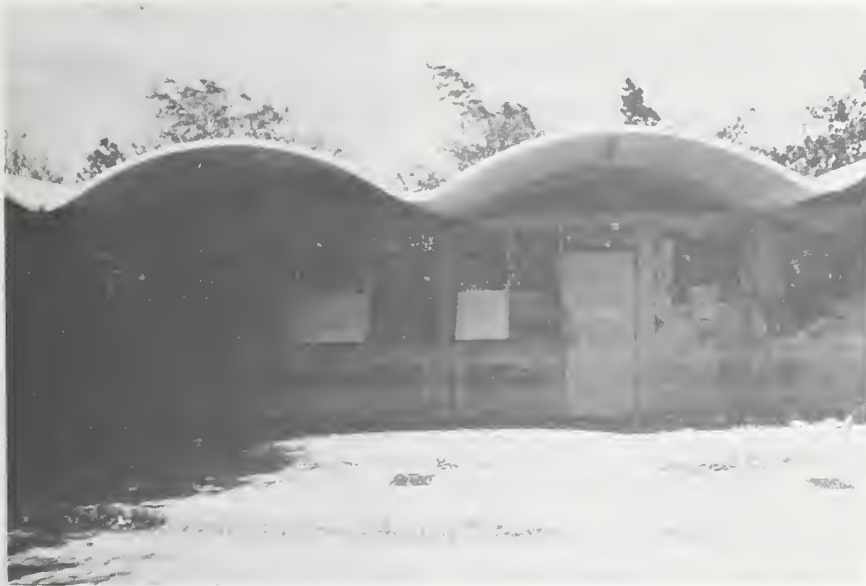
A one story building with a shell roof exhibits failures of the supporting columns, figure 53-3. A multistory reinforced concrete frame building, under construction and partially infilled shows frame failures in unfilled stories, figure 53-4.

Figure 53-3 Severely damaged columns supporting shell roof, Seminario Catolico.

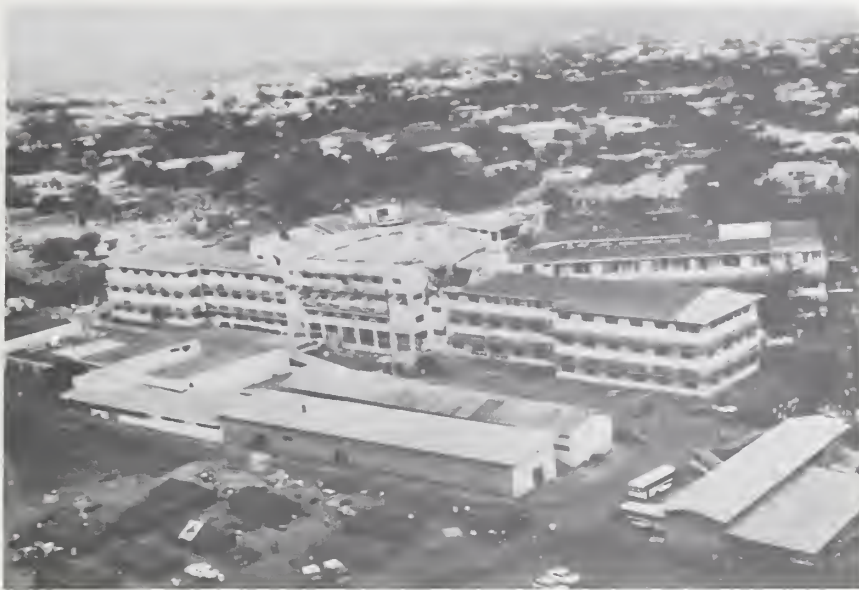
Figure 55-1 Aerial view from the rear, Hospital General El Retiro.

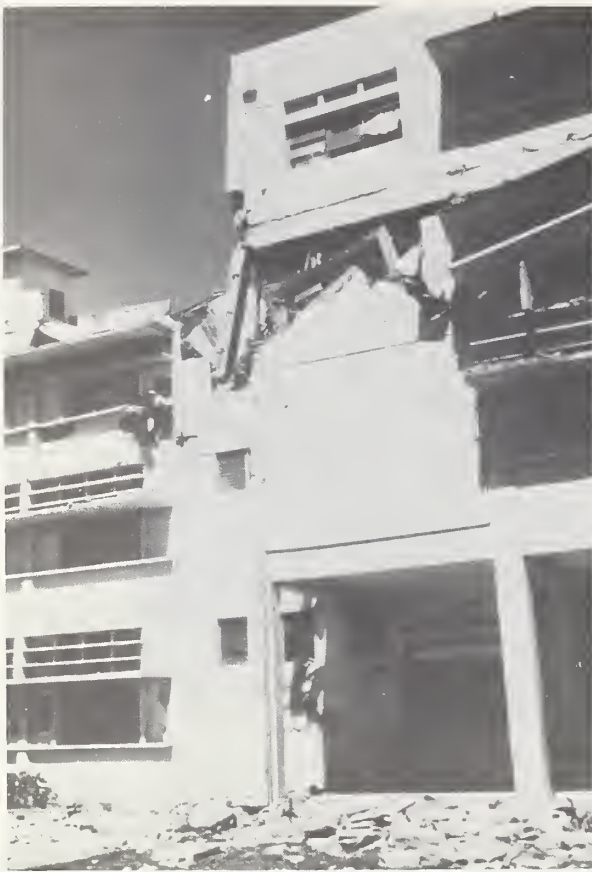
Figure 55-7 Third floor of the Hospital General El Retiro near collapse at rear.
